| CLASSIFICATION OF RECEPTOR | COMPONENTS OF EXISTING VIEW: | COMPONENTS OF PROPOSED VIEW | | |
|---|--|---|--|---|
| Public Right of Way | | | | |
| LOCATION: Punchbowl Lane | Foreground Rough grassland along the periphery of arable farmland left to right of view. Rough farm track to right of view. | As existing with development generally screened by mid distance block of woodland. Upper levels of stadium and feature spike may be visible above this vegetation. | As existing with views remaining similar to immediately following construction as development is screened by vegetation. Maturing vegetation around edges of site will provide further strengthening of this screen. | As daytime views with skyglow restricted by directional lighting. |

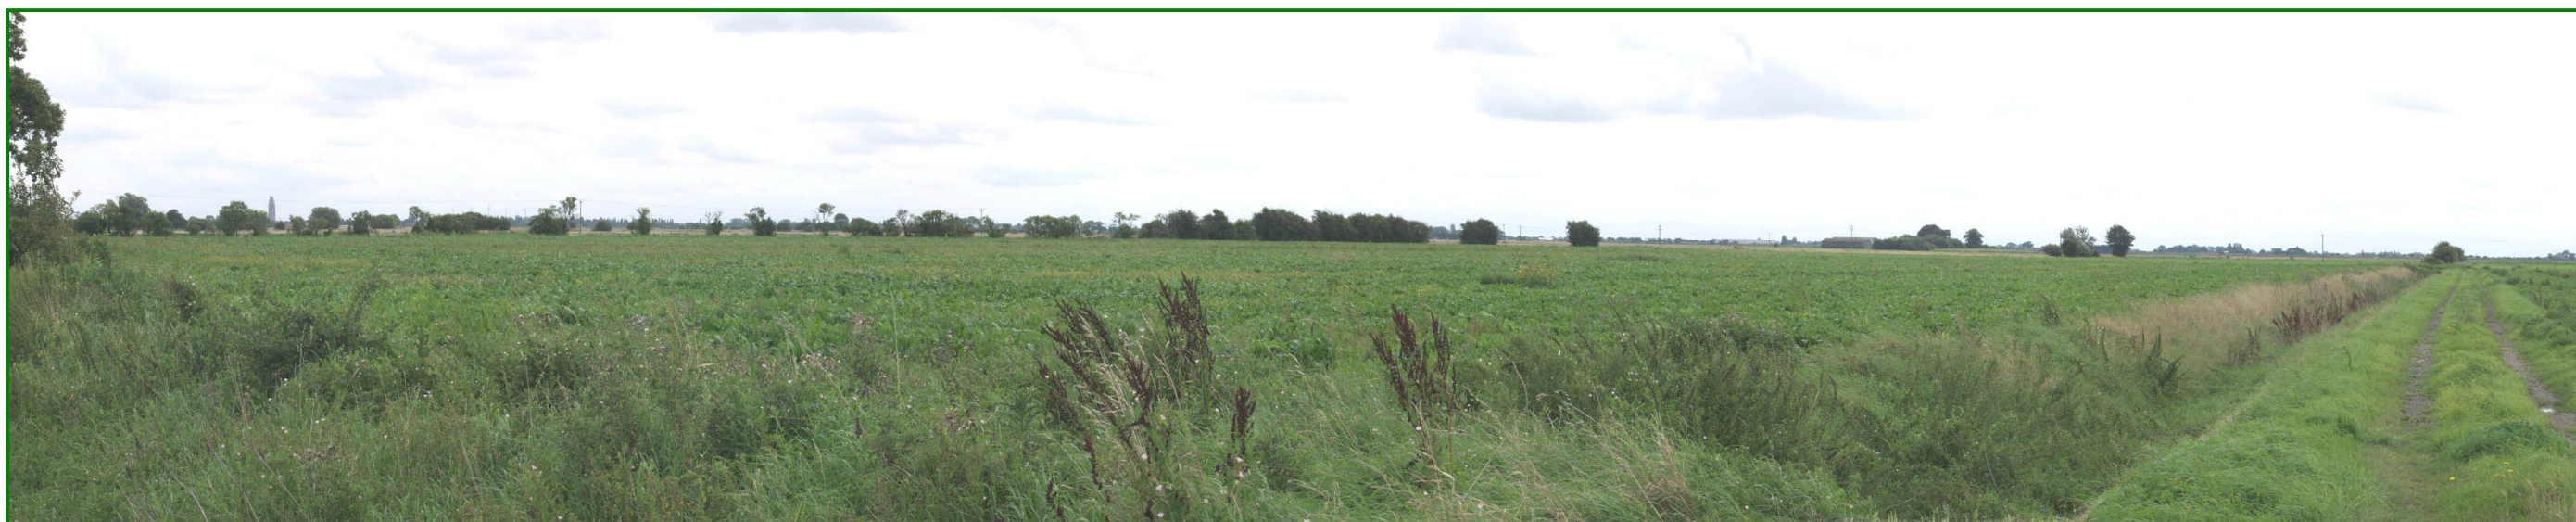
| CLASSIFICATION OF RECEPTOR | COMPONENTS OF EXISTING VIEW: | COMPONENTS OF PROPOSED VIEW | | |
|---|--|---|--|---|
| DISTANCE FROM SITE: 2.25 km from closest point | Mid Distance Arable farmland continues left to right of view. Farm track and drainage ditch to right of view. | | | |
| | Far Views Mature field boundary vegetation partially obscures development to the left to centre of view. The stump visible above this vegetation to the left of view. Mature woodland block to centre of view. Filtered views of scattered farmsteads and Great Fen through mature vegetation centre to right of view. | | | |

| CLASSIFICATION OF RECEPTOR | COMPONENTS OF EXISTING VIEW: | COMPONENTS OF PROPOSED VIEW | | |
|---|--|---|--|---|
| SENSITIVITY: Moderate | | EXTENT OF VIEW | MAGNITUDE OF CHANGE Low | SIGNIFICANCE OF EFFECT Slight Adverse |
